Contract #: 04-0120F4Cty: SF/ALA Rte: 80 PM: 13.2/13.9File #: 69.28**WELDING INSPECTION REPORT****Resident Engineer:**Pursell, Gary**Address:** 333 Burma Road**City:** Oakland, CA 94607**Report No:** WIR-011140**Date Inspected:** 13-Dec-2009**Project Name:** SAS Superstructure**OSM Arrival Time:** 700**Prime Contractor:** American Bridge/Fluor Enterprises, a JV**OSM Departure Time:** 1900**Contractor:** Zhenhua Port Machinery Company, Ltd (ZPMC), Changxing Island **Location:** Shanghai**CWI Name:** ZPMC and ABF**CWI Present:** Yes No**Inspected CWI report:** Yes No N/A**Rod Oven in Use:** Yes No N/A**Electrode to specification:** Yes No N/A**Weld Procedures Followed:** Yes No N/A**Qualified Welders:** Yes No N/A**Verified Joint Fit-up:** Yes No N/A**Approved Drawings:** Yes No N/A**Approved WPS:** Yes No N/A**Delayed / Cancelled:** Yes No N/A**Bridge No:** 34-0006**Component:** OBG**Summary of Items Observed:**

WELDING INSPECTION REPORT

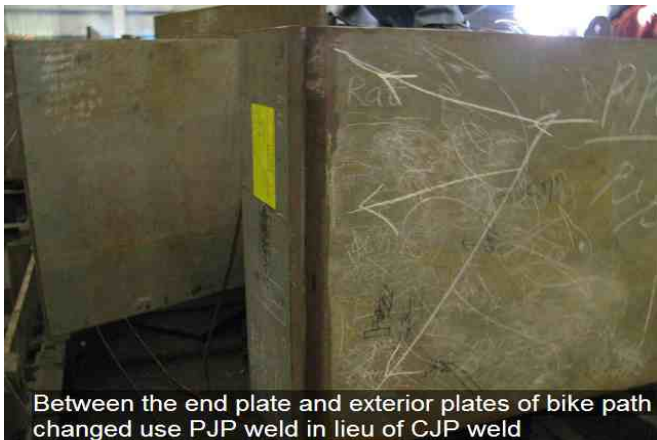
Bike path: - Caltrans QA Inspector observed two welders performed FCAW process on CJP welds for exterior plates of bike path cantilever beam. The bike path cantilever beam ID is BK-001-033-1 and BK-001-033. During observation, ABF QC informed Caltrans QA inspector that between the end plate and exterior plates of bike path cantilever beam has been changed use PJP weld in lieu of CJP weld but the weld joint remained with backing bar and the RFI file number is RFI # ABF-RFI-001933-R02 The FCAW welding process were monitored and recorded by ZPMC and ABF QC inspector. Base on Caltrans QAI observation, no discrepancies were noted.

Between the end plate and exterior plates of bike path changed use PJP weld in lieu of CJP weld

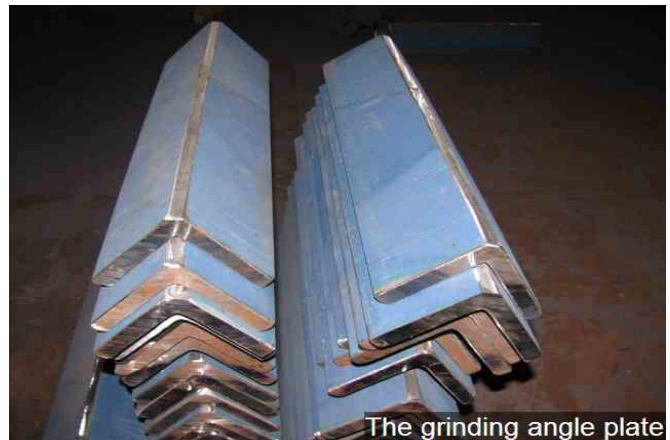
Traveler rail: - Caltrans QA inspector observed two ZPMC workers performed grinding process on the angle plates with 200 lengths. The grinding is removing approximately 6mm x 6mm from the top corner of angle plate as design drawing. The angle plates are attaching to central of traveler rails and cover a size 4mm fillet weld. The grinding process was monitored and recorded by ZPMC and ABF QC inspector. Base on Caltrans QAI

The grinding angle plate
